MARINE INVESTIGATION REPORT

M03L0124

DOWNFLOODING AND GROUNDING

FISHING VESSEL *EVAN RICHARD*
OFF ANTICOSTI ISLAND, QUEBEC
29 SEPTEMBER 2003

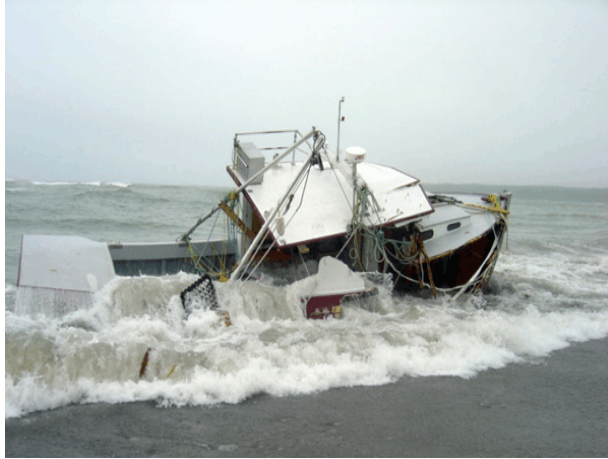
The *Evan Richard* was damaged when it went aground on shore about 3 nautical miles from the position where the Mayday was broadcast. It was completely destroyed by the waves and is now considered a total loss.

Photo 3. The *Evan Richard* on an Anticosti Island beach a few hours after sinking

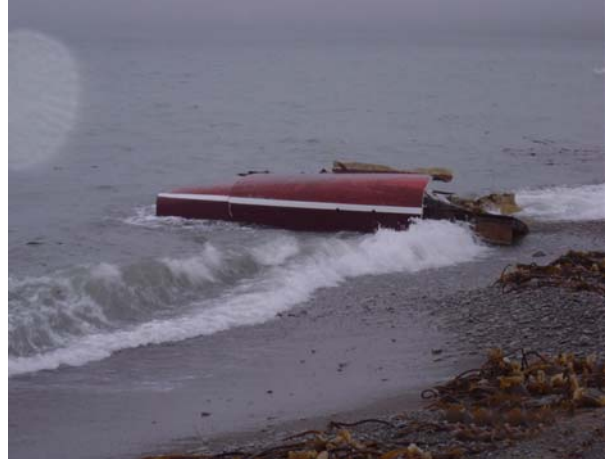
Photo 4. The wreckage of the *Evan Richard* on an Anticosti Island beach on 03 October 2003

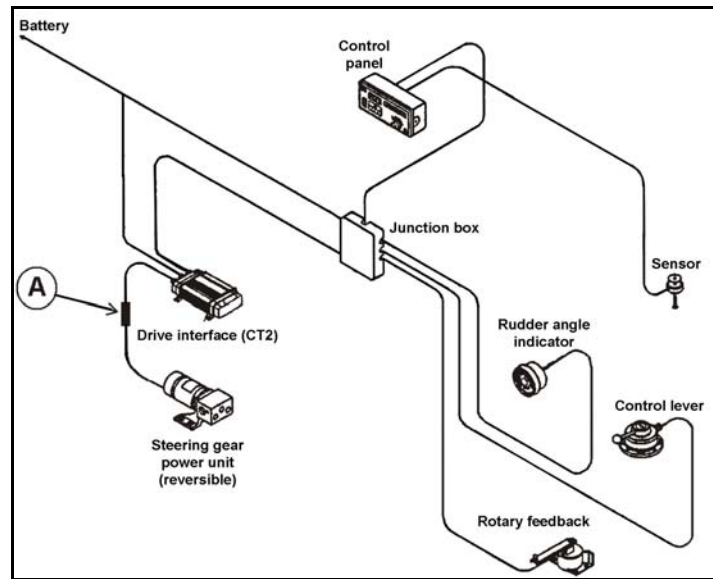
Figure 2. Schematic of power assist electrical circuit on the *Evan Richard*

During the installation, a 20 A fuse was added between the drive interface and the power unit (see "A" in Figure 2). Experience showed that the power unit of the steering gear tended to fail at sea. The fuse was added to limit maintenance and the need to replace this part.

On the sea trials during the days preceding the departure, the master told the technician that the fuse blew several times. Evaluation indicated that the fuse blew when the wheel was held hard right or hard left; the system was not equipped with a limit switch. This caused an overload in the circuit and blew the 20 A fuse. To solve this problem, it was suggested that a different type of power assist be installed, but the master decided to keep the system already installed due to the additional replacement cost.

According to the information received, the steering gear failed when the power assist was used to heave to. Inspection of the power assist circuits revealed that a fuse connected in series between the steering gear power unit and the drive interface had blown.

To protect the power unit of the steering gear from current variations when the system is operating normally, the manufacturer provided 30 A thermal protection inside the drive interface. According to the manufacturer, adding a 20 A fuse (see "A" in Figure 2) does not increase system safety and can even prevent it from operating properly.

It is important to note that the system was designed so that the steering gear would be used with either the telemotor or the power assist. Therefore, when the power assist failed, the telemotor could have been used to steer. In other words, the steering gear did not fail.

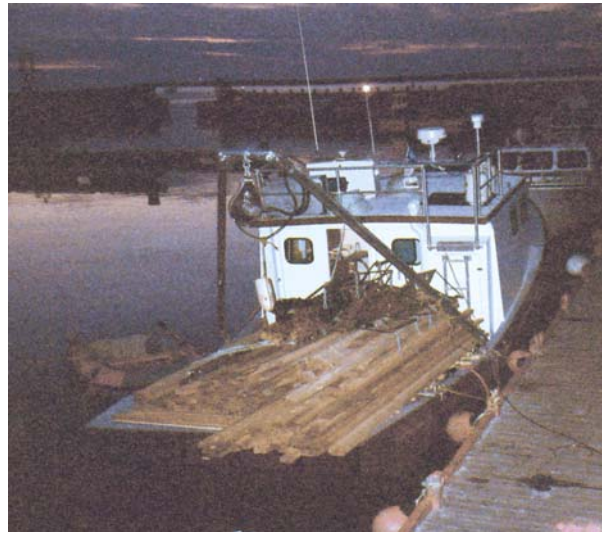
There were no freeboard marks or load lines on the *Evan Richard*. When the boat was loaded, the distance between the surface of the water and the top of the bulwark was some 45 cm (see Appendix A). The scuppers had been blocked with wooden plugs, but since they were not watertight, an electric pump was installed to discharge water from the after deck.

Photo 5. Aft view of the *Evan Richard* with its load prior to departure from Bas Caraquet

The *Evan Richard* had a cargo of some 6570 kg, which was about twice the usual cargo weight at the time. With this cargo, the after deck was approximately 20 cm below the waterline and the plugged scuppers were not watertight (see Appendix A). The electric pump used to discharge water from the after deck had to operate throughout the whole voyage to keep the crew safe.

1. The *Evan Richard* was overloaded to the point where the scuppers were submerged, thereby facilitating downflooding.
2. When the power assist failed, the master did not use the steering telemotor.
3. The anchorage chosen provided little shelter from winds and waves from the southeast.

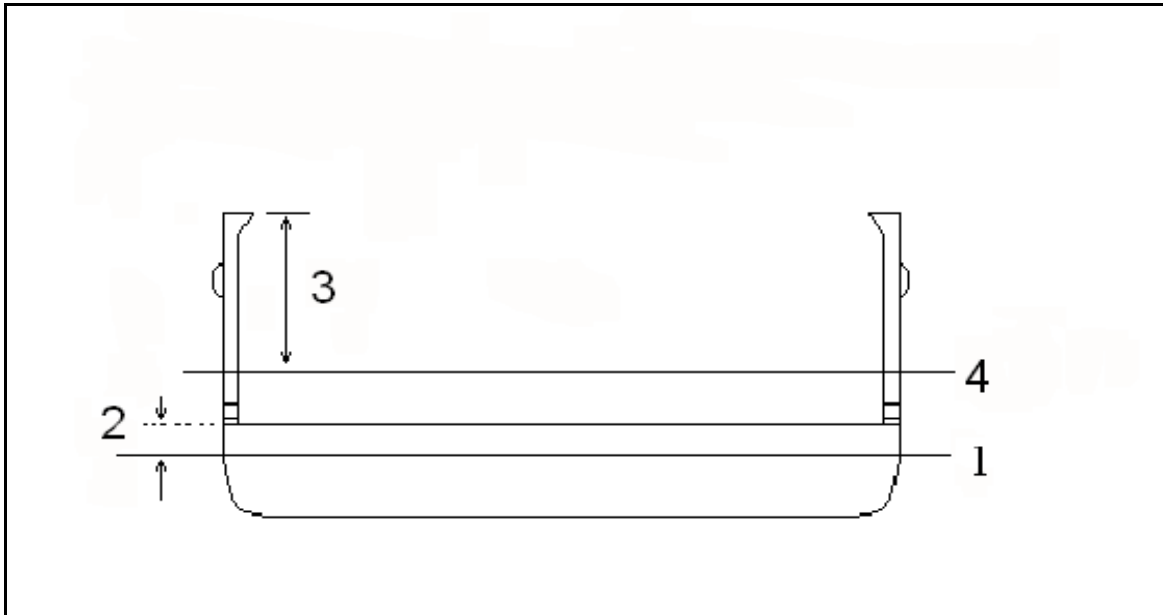
Appendix A – Cross-Section of the *Evan Richard*

Cross-section (not to scale) of the *Evan Richard* aft of the accommodation

1. Waterline in light condition.
2. Distance between waterline and watertight after deck: approximately 10 cm in light condition (not to scale).
3. Distance between surface of water and top of bulwark: approximately 45 cm.
4. Waterline when loaded on departure from Bas Caraquet.
